Environmental Degradation of Historical Materials in Jeddah, Saudi Arabia

A thesis submitted to the University of Bristol in accordance with regulations of
the degree of Doctor of Philosophy at the

Interface Analysis Centre, Faculty of Science

February 2020

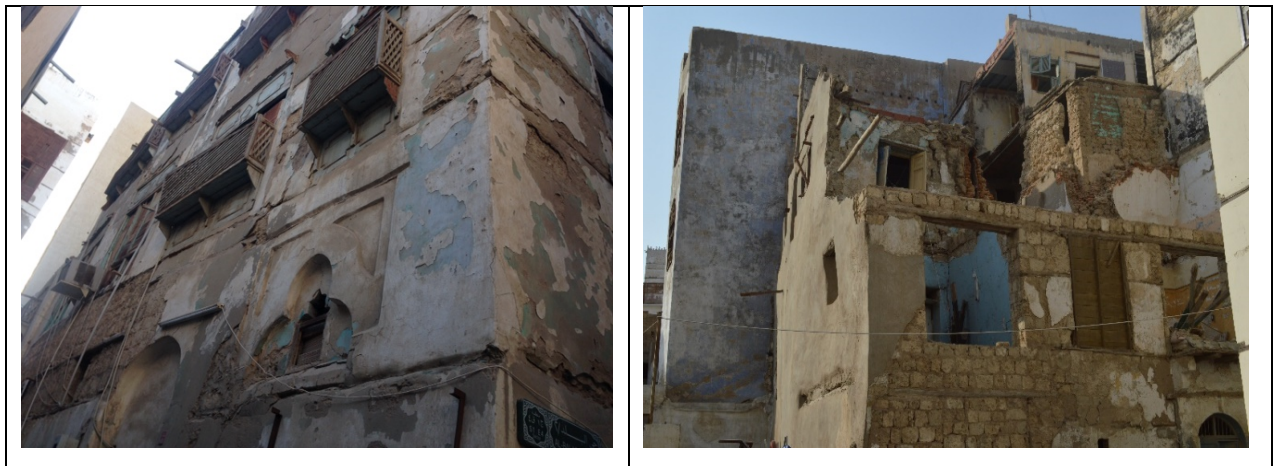
As can be seen from the photos, the buildings are in an advanced state of degradation, that will be costly to restore. These buildings now require urgent attention to be preserved as historic treasures for future generations.

Figure 1.5.1 An example of historical buildings degradation in Jeddah.

The historical building site in Jeddah is surrounded by industrial activity e.g. the industrial area to the south, the oil refinery, the Jeddah port and the desalination plant (Figure 1.4.1). In addition, the historical buildings in Jeddah have been neglected for a long time without any condition monitoring scheme. Significant degradation has now been observed on the buildings as shown in Figure 1.5.1., leading to this current study.

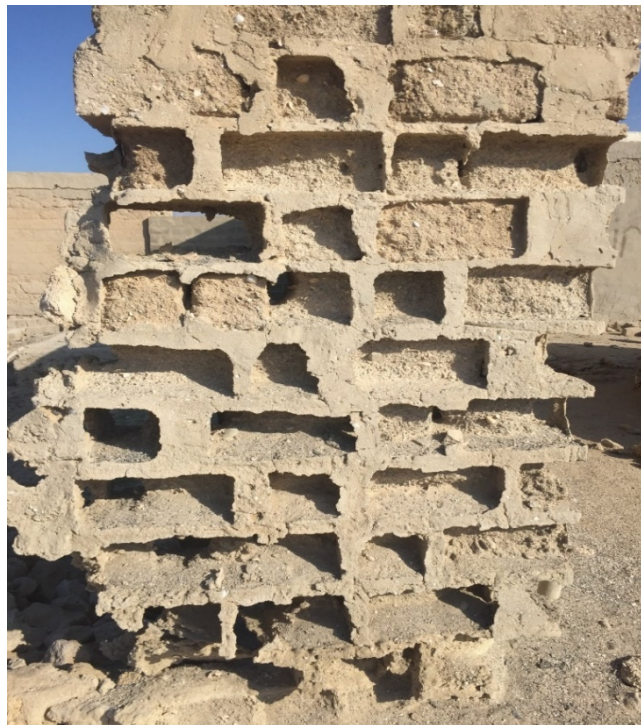
Figure 3.2.1 Photograph showing a clear example of the effect of weathering on historical buildings in the United Arab Emirates.

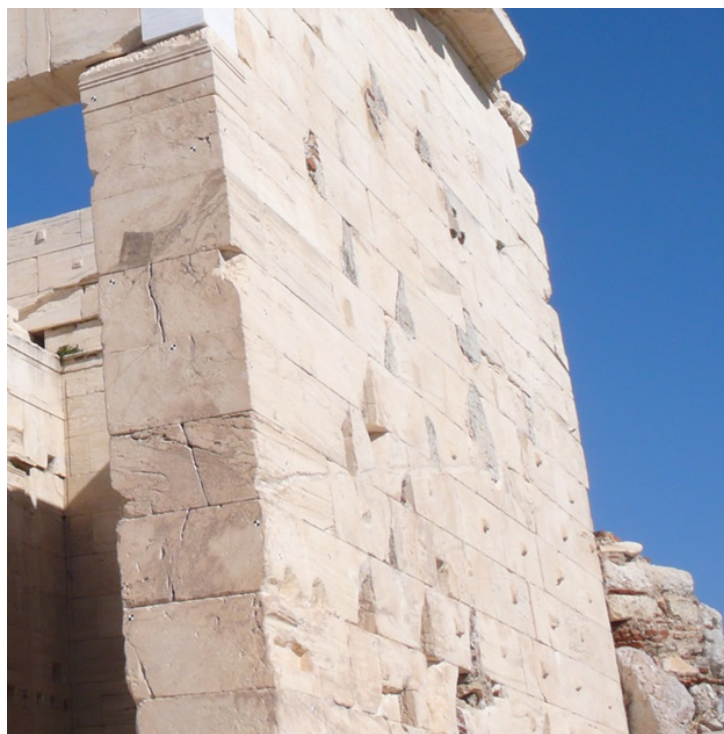
According to Siegesmund et al, and Vazquez et al, marble degradation is linked with the increase in porosity and a general increase of the maximum pore radii. In-situ damage analyses in combination with laboratory tests on marble ‘bowing potential’ were used to constrain factors that may influence the failure risk. Bowing is a well-established phenomenon seen in marbles used as building veneers. This shape of this rock weathering occurs because of external factors such as temperature, humidity, the system for anchoring the marble slabs or the panel dimensions [57, 58]. According to YSMA (Greece’s Acropolis Restoration Service), rainwater, which is acidified by carbon dioxide, sulphur dioxide and nitrogen oxides from air pollution slowly dissolves the marble. Such damage on marble cladding can lead to the loss of cohesion and ultimately in their falling off [59].

Figure 3.2.2 Photograph showing a clear example of the effect of dissolution and atmospheric pollution on Propylaia in Greece [59].

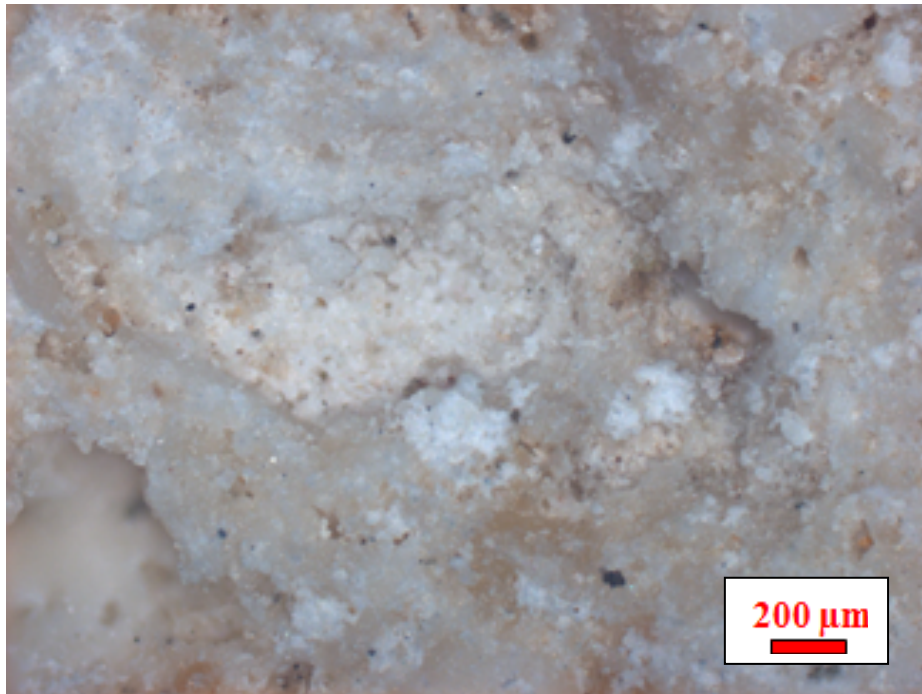
Figure 5.2.1 presents an optical micrograph of the stone surface collected from the quarry (Manqabah). The surface topography revealed a mixture of dense white and brownish colours and in addition, a black deposit was observed. The optical micrographs obtained from the stone surfaces from four houses are shown in Figure 5.2.2.

Figure 5.2.1 Optical micrograph of the stone surface collected from the Manqabah quarry.
